## Technical paper

# The Generation Mechanism of Blisters Formed on Oil Seals for Construction Machinery (The Second Report)

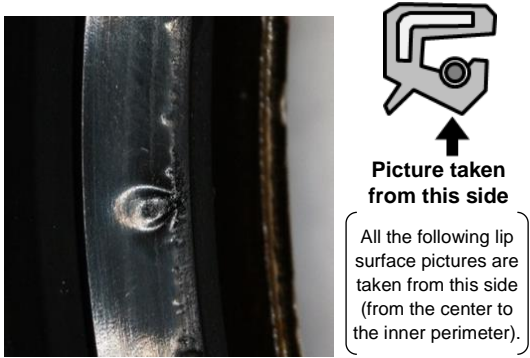
The sealing action of the oil seal may be lowered due to various causes such as abnormal wear of the lip, reversal of the lip, and deterioration of the lip rubber material. In particular, the oil leak faults due to bumps called blisters which are generated on the atmosphere side at the seal lip tips, as shown in **Fig. 1**, have been observed since before. Until now, when a fault due to blisters has occurred, we took action, for example, by changing the seal shape or rubber material. Blister generation has, however, not been completely prevented yet, and to prevent it, it is necessary to figure out the blister

Fig. 1 Example of a blister generated on an oil seal [1]

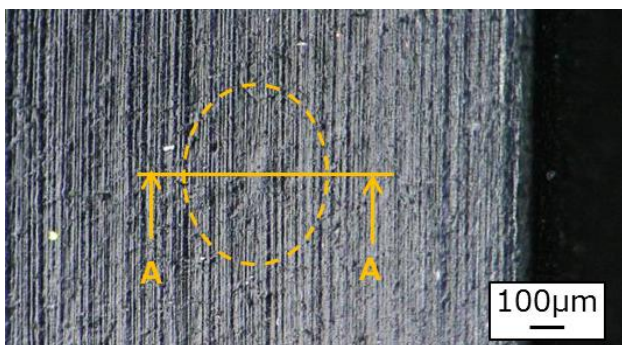
**Fig. 3** Oil seal lip surface after testing

A minute swelling was found on the atmosphere-side surface of the oil seal’s main lip after testing (refer to **Fig. 3**). In order to check the inside of this swelling, a minute section was fabricated from the surface, using a Focused Ion Beam (“FIB”) and observed. **Fig. 4** shows the observation result. Cavities were recognized (arrowed) around the fillers (parts looking black and uniform) near the surface. It is inferred that the air diffused inside the rubber while held at a high temperature must have been coagulated in the cavities without being able to go outside during cooling.

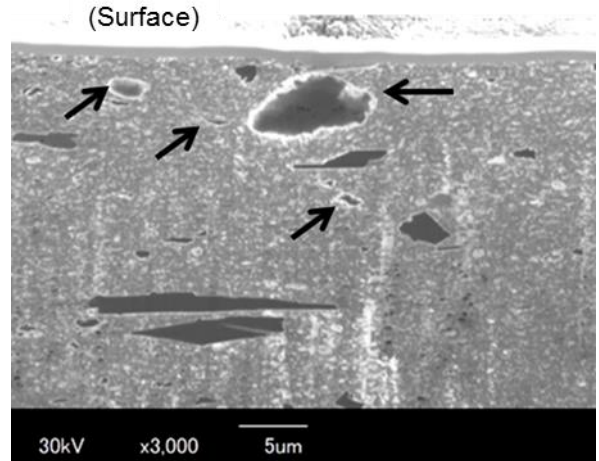
Thus, we have confirmed that a thermal cycle is one of the factors for the cavity formation around the fillers which serve as a starting point of blisters.

**Fig. 4** Cross section of swollen surface of lip (Section A-A in Fig. 3)

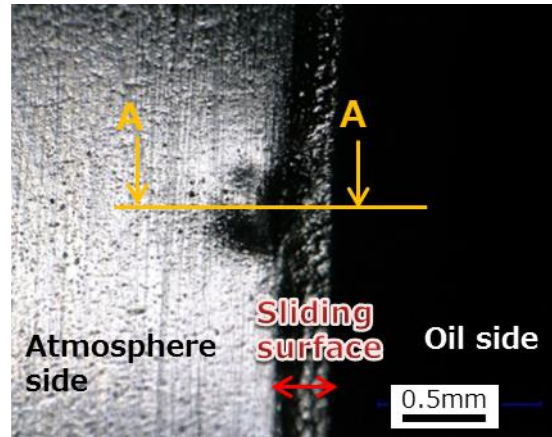
When the test seal was checked after testing, swelling like a blister was generated in the cut section on the lip surface (refer to Fig. 7), and when pressed with tweezers, oil came out of the inside. Fig. 8 (a) shows the cross section after cutting this swelling area of the lip with a cutter. It can be confirmed that the cut cavity is wider, affected by a negative pressure, compared with the cross section of another sample prior to the negative pressure test which is shown in Fig. 8 (b). Though we were not able to check the crack propagation in this study, it is presumed that if the time is increased, the crack will be propagated.

**Fig. 7** Lip surface after verification test (Swelling generated in the cut section)

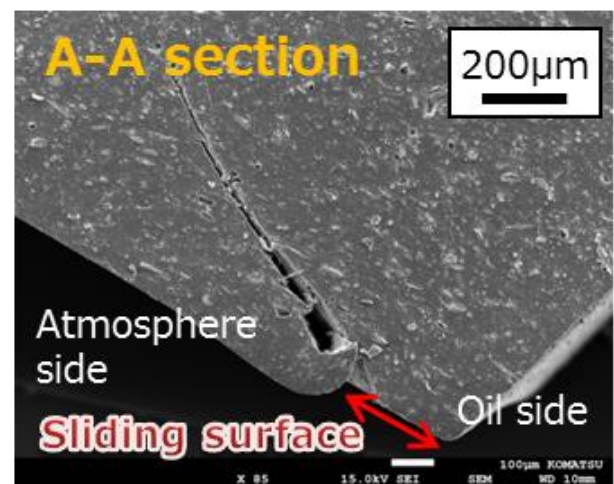
Thus, it was made clear that a negative pressure generated on the atmosphere side of the main lip was one of the factors for promoting the blister growth.

(a) Section A-A after negative pressure test

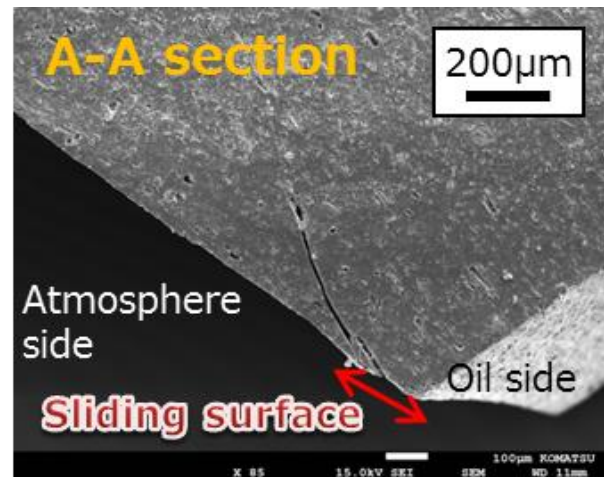
(b) Section A-A of another sample prior to negative pressure test

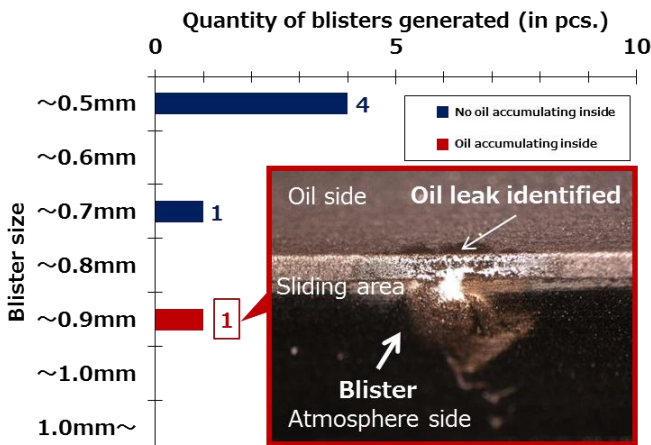
The product investigation was conducted on the oil seals in which blisters were generated in a component bench test. Fig. 9 shows the summary of the generated blisters. When the inside oil accumulating was checked for by making a cut in each blister, no accumulating oil was identified inside the blisters except for the largest one (size 0.9 mm) (refer to Fig. 9).

Fig. 9 Summary of blister generation on oil seals in component bench test

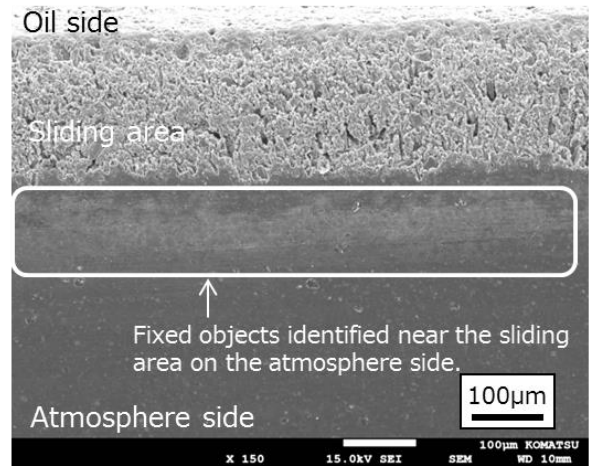
When the actual products were investigated in detail, such faults as the roughness of the sliding surfaces near blisters and the falling off of fillers were identified (Fig. 10). That can be considered to have been caused by the possibility that the sliding surface may not have been provided with sufficient amount of lubricating oil. It was inferred that the sliding torque (friction coefficient) was increased under this poor lubrication conditions, which caused the cracks on the surface and in the inside (Fig. 11) to be propagated, finally leading to their interconnection with surface cracks and subsequent inflow of oil.

Fig. 10 Lip surface near blister

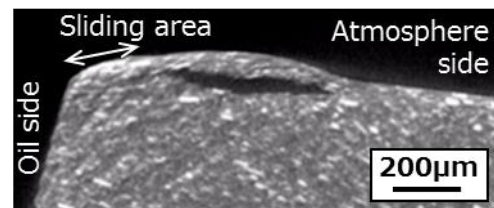
Fig. 11 X-ray CT image of blister section (Blister size: 0.7 mm)

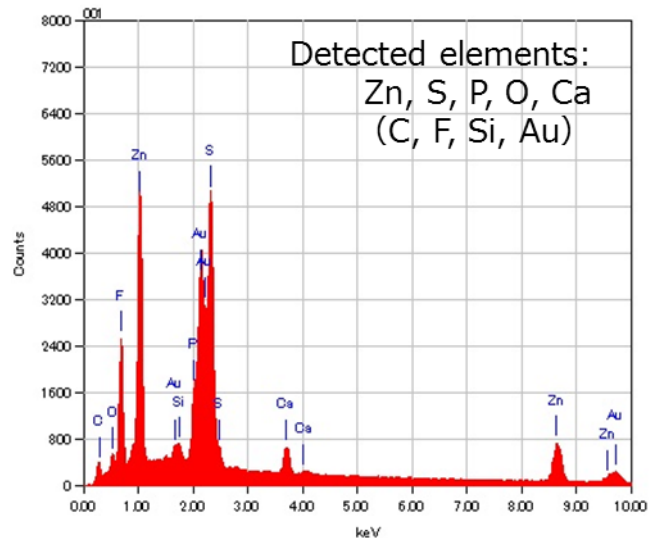
Fig. 12 Results of elemental analysis (energy dispersive X-ray spectrometry (EDS)) of fixed objects identified on lip surface near blister

Besides, an elemental analysis was conducted on the fixed objects identified near the sliding area on the atmosphere side (refer to Fig. 10) with an energy dispersive X-ray spectrometer (EDS). The result indicated that the major components of the fixed objects were oil additive components such as Zn, S and P (Fig. 12). Thus, from the fact that the fixed objects derived from oil additive components were generated, it can be inferred that the seals were locally exposed to a high temperature.
