Technical Paper

Development of Oil Passage Integrated Cylinder

Kotaro Asano

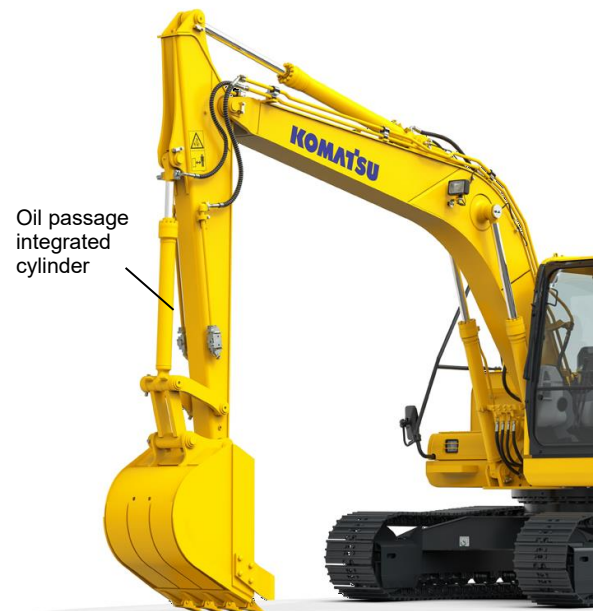
Fig. 1 PC130-10M0 oil passage integrated cylinder installed vehicle

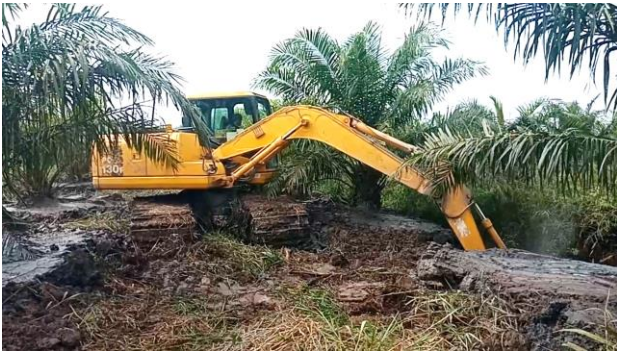
Fig. 19a Scene of actual operation
(water channel maintenance)

An operation survey was conducted in markets of Japan, Indonesia and Thailand, for a total of 10 units. All of these vehicles were used in an environment where oil leaks and damages to piping had occurred with the conventional installation, but installing the cylinder in reversed orientation is confirmed to have eliminated malfunctions.

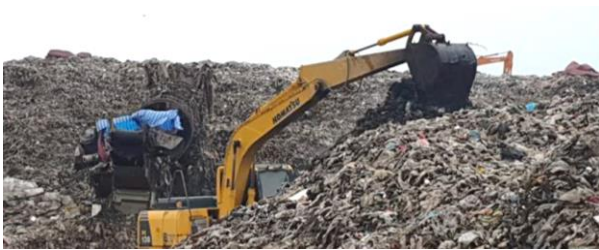
Fig. 19b Scene of actual operation
(waste management)
