## Technical paper

# The Generation Mechanism of Blisters Formed on Oil Seals for Construction Machinery (The Second Report)

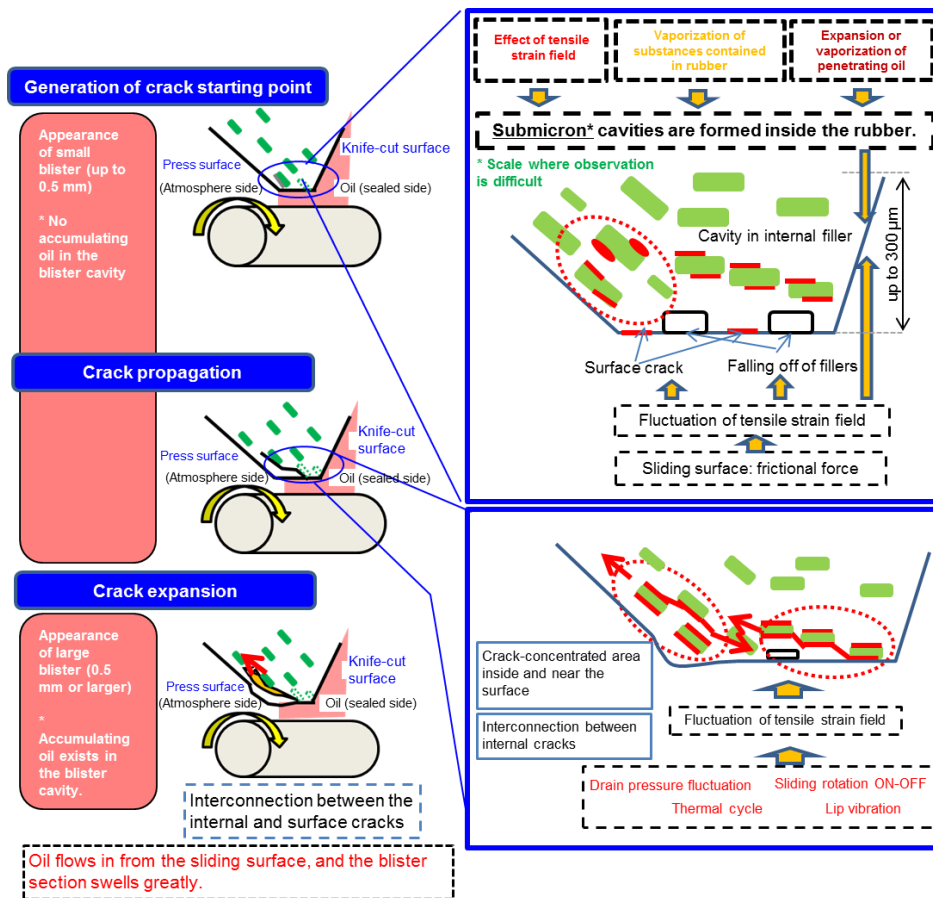
Fig. 2 Generation mechanism of blisters formed on oil seals for construction machinery [1]

It was inferred in the previous report that the process from the generation to the growth of the blisters on the oil seals for construction machinery could be roughly divided into three stages, considering from the observation results of blisters generated in oil seals used on a construction machine (refer to Fig. 2).

The crack starting point cavities around the filler interconnect with each other, thereby causing the blister to grow.

When the crack propagates to the surface, the inside of the crack interconnects with the sliding surface and the oil flows into and fills the inside of the blister.

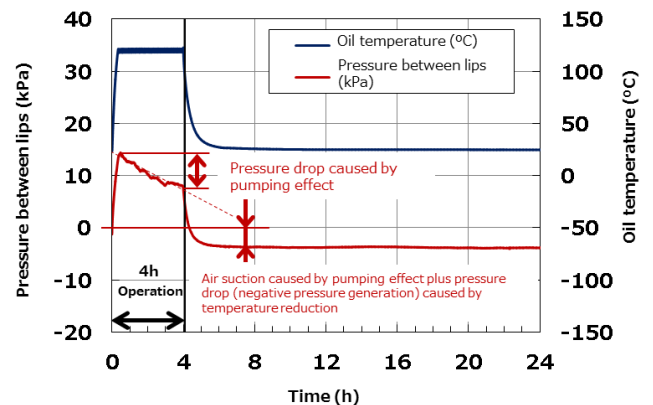
**Fig. 5** Results of lip-to-lip pressure measurement test

An oil seal keeps oil inside because fluid flows from the atmosphere side to the sealed fluid side due to the pumping action during rotation. However, if there is any dust lip, the air between lips is also sucked into the sealed fluid side, which lowers the pressure. And then, as it stops and cools down, the pressure is further lowered, and a negative pressure was found to be generated between lips (refer to **Fig. 5**).

Rotational speed: 2,050 rpm  
 Internal pressure: 0.05 MPa  
 Sample oil: Genuine Power Line Oil TO10 (SAE10W)

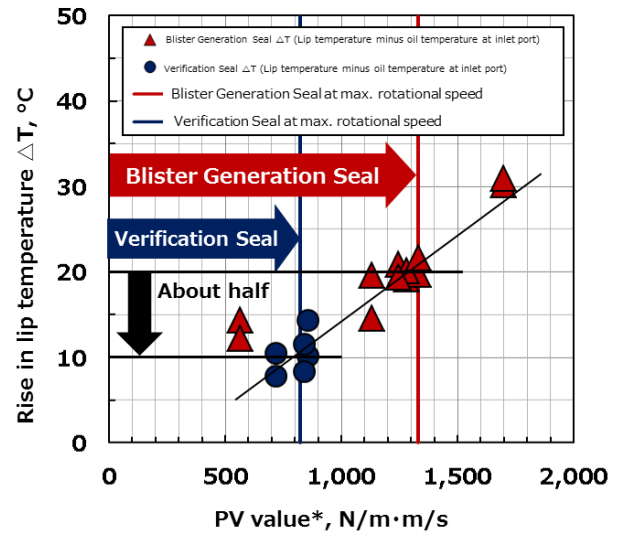
Fig. 13 Measurement results of lip temperature rises in component

First, the “Blister Generation Seal” and “Verification Seal” were integrated into the same component sequentially, and the lip temperature was measured when the rotational speed (rpm) was changed for each. Fig. 13 shows the results summarized with “PV values (the product of seal’s tension and circumferential speed)” and “rises in lip temperature”.

Since the heat generated by sliding ( $\alpha$ , rise in lip temperature) is proportional to the product of friction coefficient and contact load (bearing), and circumferential speed, the inclination of the graph corresponds to the friction coefficient. It is considered that there is no significant difference between the lubricated conditions of the oil seals because they lie on almost the same approximate lines. Hence, we have found that the rise in lip temperature can be reduced by half if the tension is reduced (Fig. 13).

A component bench test was similarly performed on the Verification Seal. As a result, it was confirmed that only one minute blister was generated, which indicated that the generation and growth of blisters were suppressed.

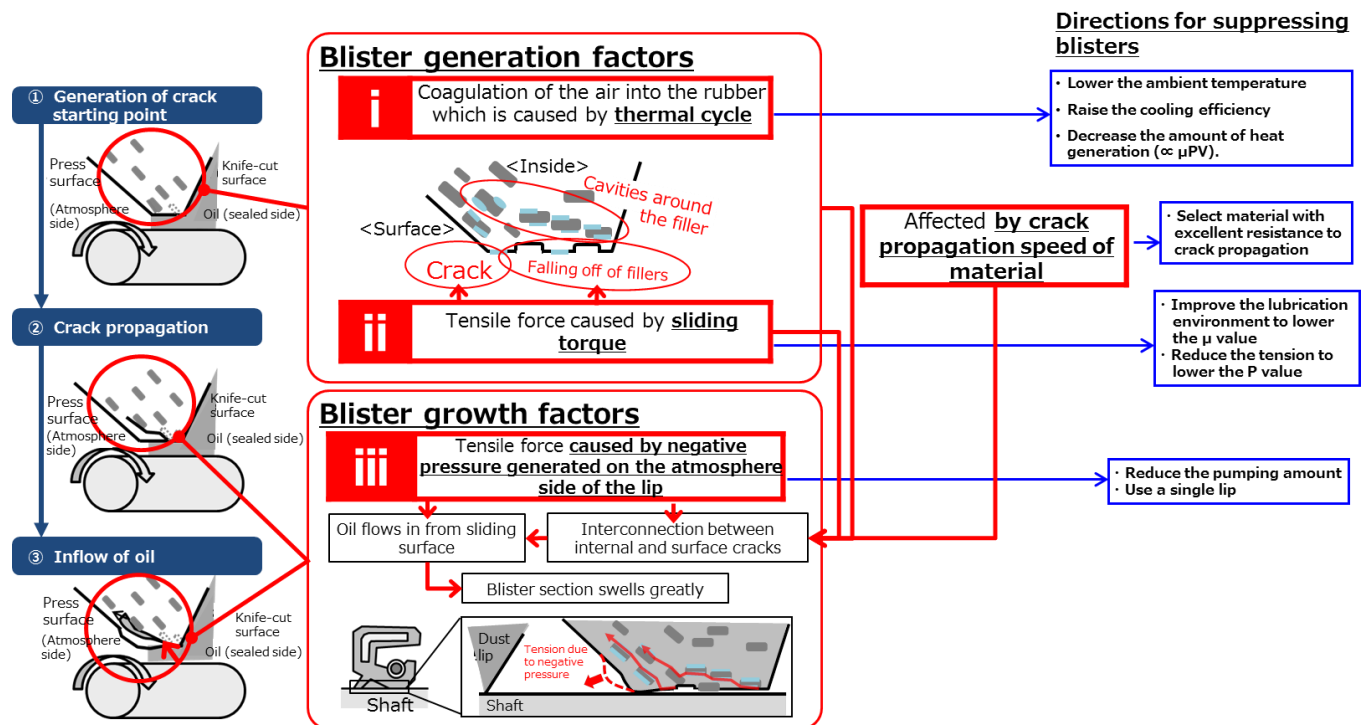
Fig. 14 Blister generation and growth mechanism and directions for suppressing blisters

In this study, we were able to clarify the driving forces for the generation and propagation of cracks in the rubber which were required for the generation and growth of blisters, which led to the directions for suppressing the blisters as shown in **Fig. 14**.
